Coastal Flood and Wind Event Summaries

COASTAL FLOOD AND WIND EVENT SUMMARIES

This resource supplements Chapter 2 of *Coastal Construction Manual*. It summarizes coastal flood and wind events that have affected the continental United States, Alaska, Hawaii, and U.S. Territories since the beginning of this century.

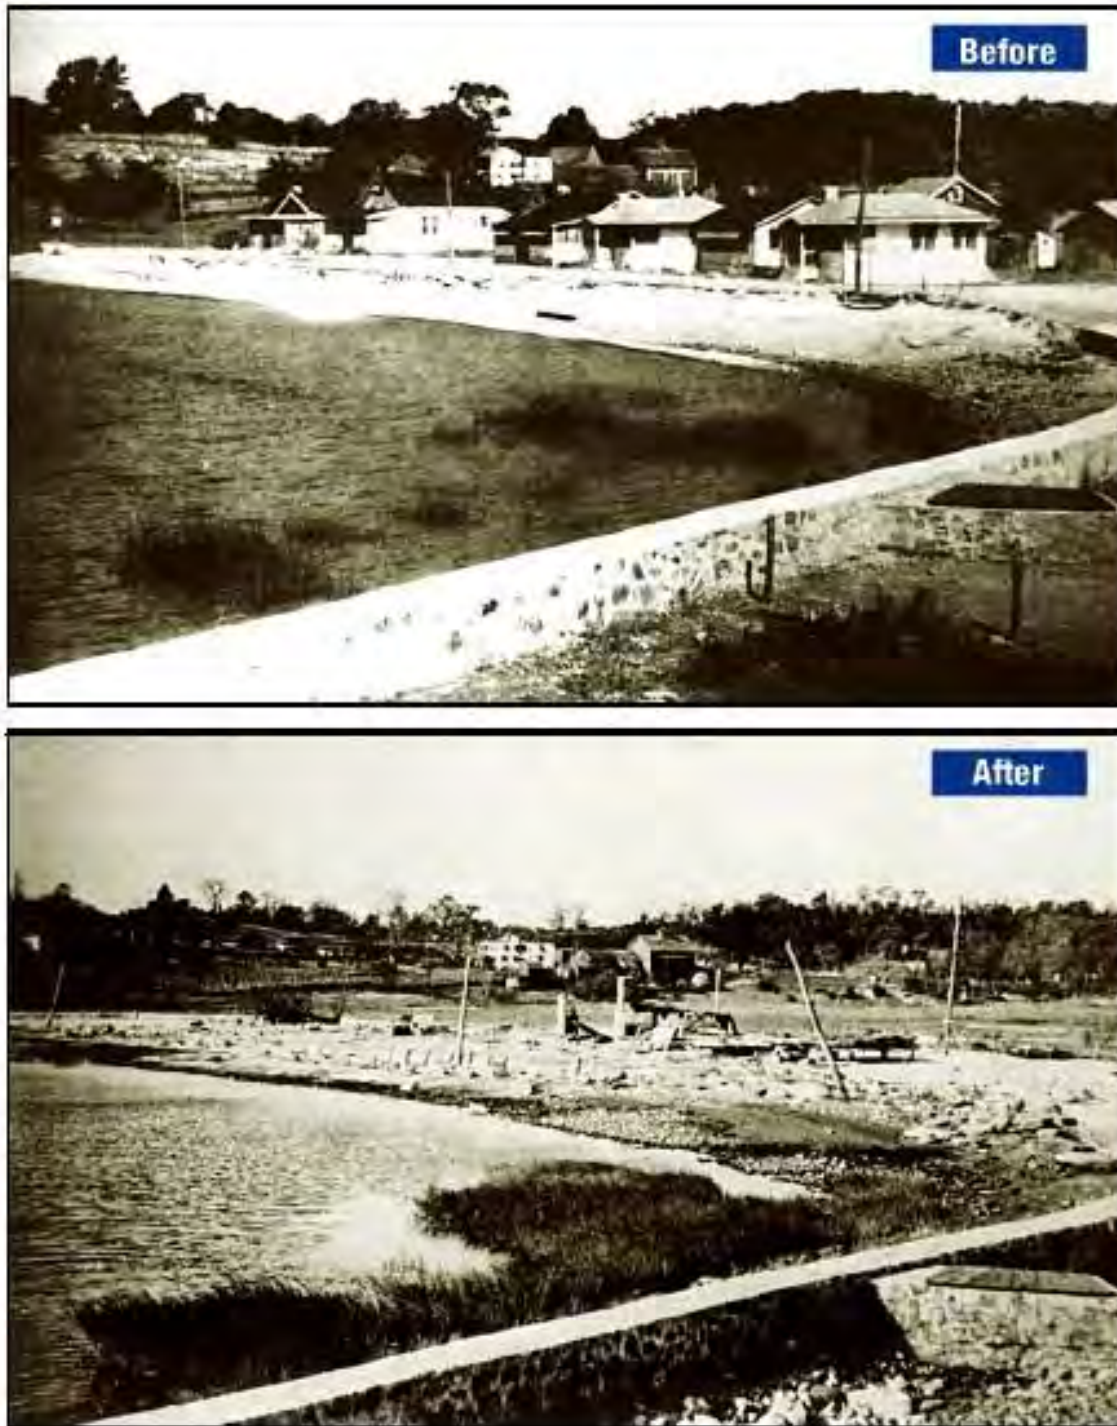
Figure 1. —“Long Island Express” Hurricane. Schell Beach, Guilford, CT, before and after the storm. Non-elevated houses at the shoreline were destroyed.

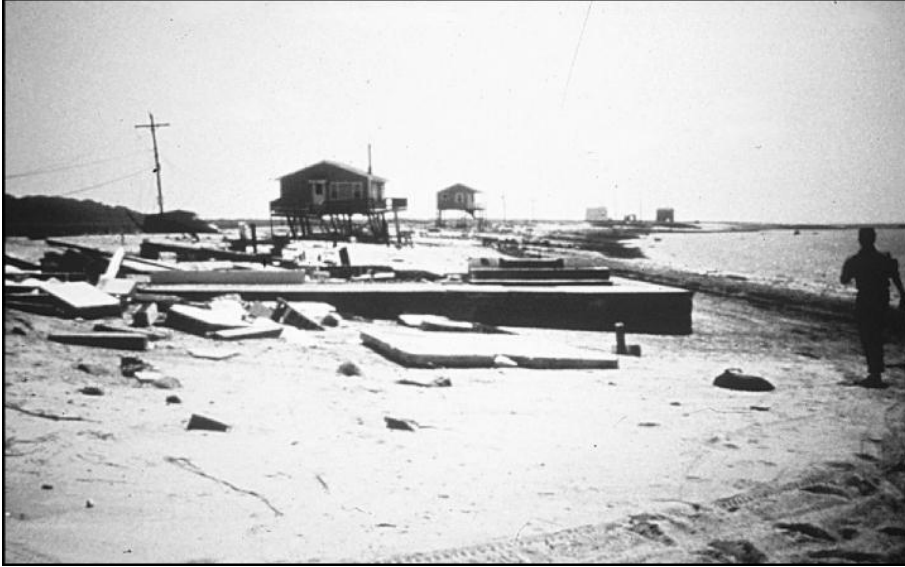
- Buildings that were constructed before the date of the Flood Insurance Rate Map (FIRM) for their community and that had not been elevated, or were not elevated sufficiently, suffered major damage or complete destruction; some destroyed buildings appeared to have had insufficient foundation embedment.

Figure 2. Hurricane Bob (1991) destroyed 29 homes along this reach of Mattapoisett, MA.

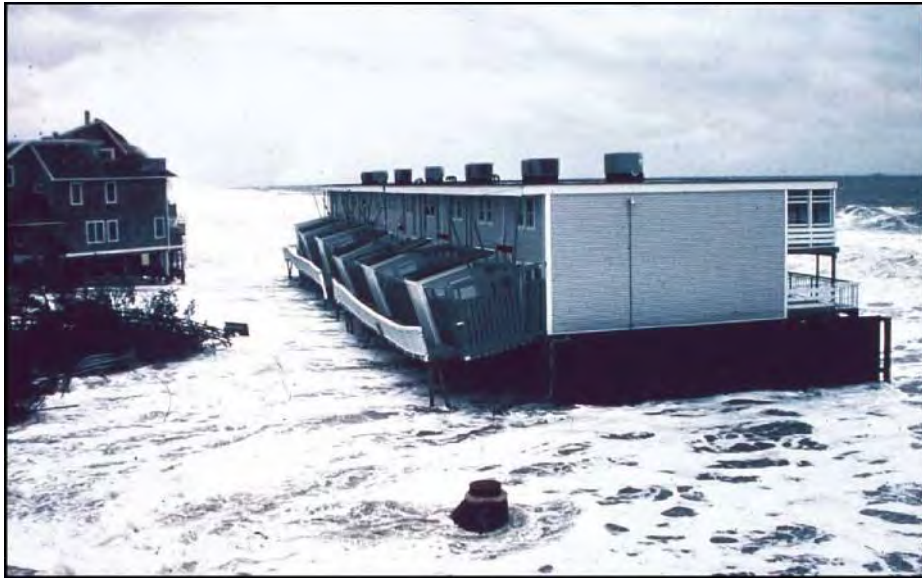
- Some buildings had poorly located or fastened utility lines. For example, some sewer stacks and sewer laterals failed as a result of erosion and flood forces. The report provides guidance on locating and fastening sewer connections to minimize vulnerability.
- Many pile-supported buildings were observed to have sustained damage to at-grade or inadequately elevated mechanical equipment, including air conditioning compressors, heat pumps, furnaces, ductwork, and hot water heaters. The report provides guidance on proper elevation of these units.

Figure 9. 1992 storm impacts at Dewey Beach, DE. Note collapse of deck on landward side of building.

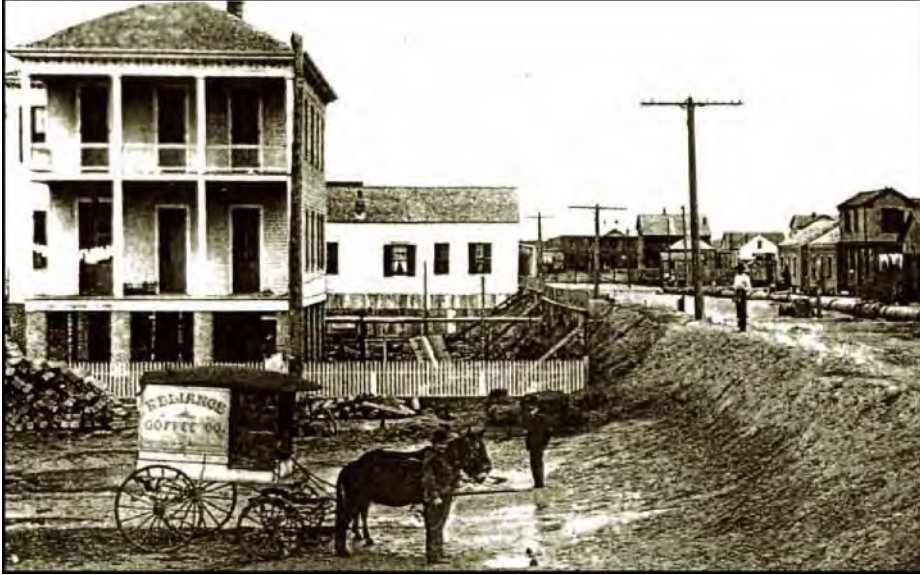
1900, September 8 – Galveston, TX. This Category 4 hurricane was responsible for over 8,000 deaths. The storm caused widespread destruction of much of the development on Galveston Island and pointed out the benefits of siting construction away from the shoreline. As a result, the city completed the first, large-scale retrofitting project (see Figure 19): roads and hundreds of buildings were elevated, ground levels in the city were raised several feet with sand fill, and the Galveston seawall was built (Walden 1990).

Figure 16. Galveston on two levels—the area at the right has already been raised; on the left, houses have been lifted, but the land is still low.

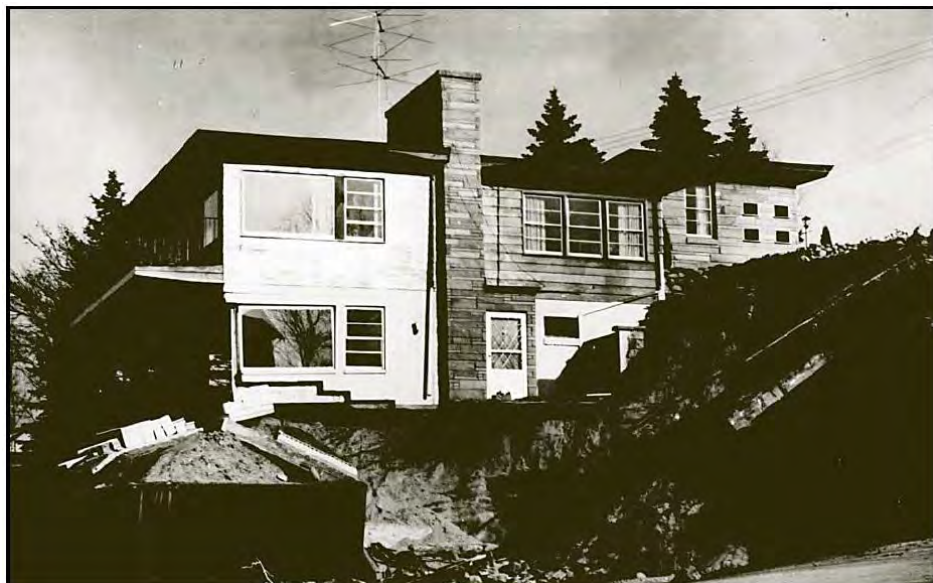
1951, November 7 – Storm on Lake Michigan. After 20 years of lower than-average levels, the water level on Lake Michigan in November 1951 was slightly above average. The November 7 storm caused extensive erosion along the southeast shore of the lake, undermining houses and roads (see Figure 32). Damage observed as a result of this storm is consistent with the concept of Great Lakes shoreline erosion as a slow, cumulative process, driven by lakebed erosion, high water levels, and storms.

Figure 25. House on southeastern shoreline of Lake Michigan undermined by erosion during storm of November 1951.

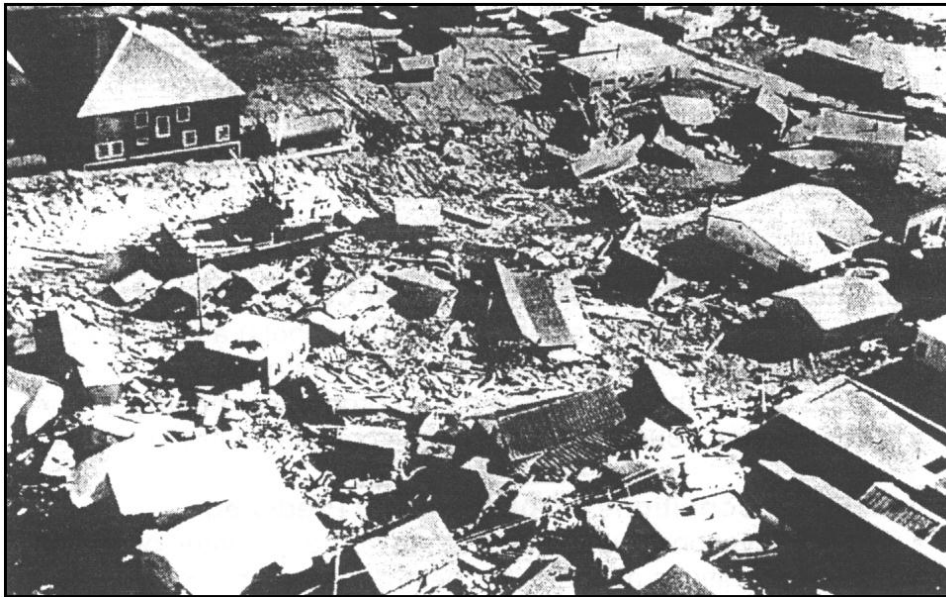
1964, March 27 – Alaska Tsunami. This tsunami, generated by the 1964 Good Friday earthquake, affected parts of Washington, Oregon, California, and Hawaii; however, the most severe effects were near the earthquake epicenter in Prince William Sound, southeast of Anchorage, Alaska (Wilson and Tørum 1968). The tsunami flooded entire towns and caused extensive damage to waterfront and upland buildings (see Figure 25). Tsunami runup reached approximately 20 feet above sea level in places, despite the fact that the main tsunami struck near the time of low tide. Also, liquefaction of coastal bluffs in Anchorage resulted in the loss of buildings.

Figure 26. 1964 Good Friday earthquake. Damage in Kodiak City, AK, caused by the tsunami of the 1964 Alaskan earthquake.

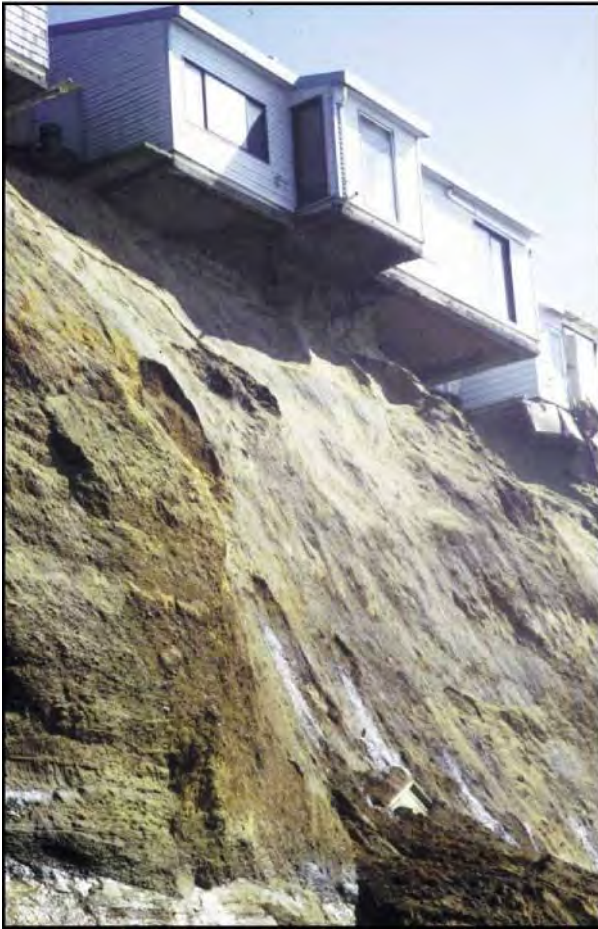
1997-98 – Winter Coastal Storms, California and Oregon. Another series of severe El Niño-driven coastal storms battered the Pacific coast. The distinguishing feature of the 1997-98 event was rainfall. The California Coastal Commission (1998) reported widespread soil saturation, which resulted in thousands of incidents of debris flows, landslides, and bluff collapse (see Figure 26).

Figure 27. Winter coastal storms, California and Oregon (1997– 1998). House in Pacifica, CA, undermined by bluff erosion.

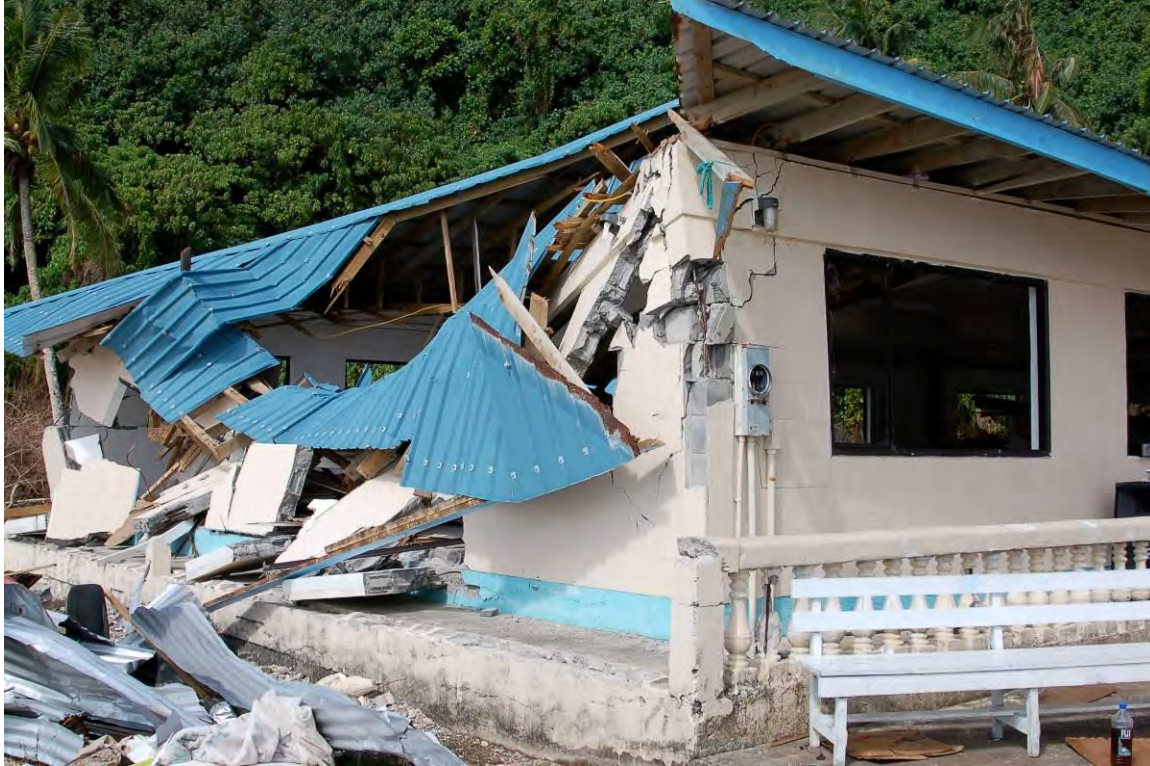
15 to 40 feet above sea level. At least 275 residences were destroyed by the tsunami and several hundred others were damaged (Figure 31). Damage to commercial buildings, churches, schools and other buildings was also widespread. Elevated buildings and buildings farther inland generally performed better. Thirty four people were killed by the tsunami.

Figure 32. Tsunami damage at Poloa, American Samoa.

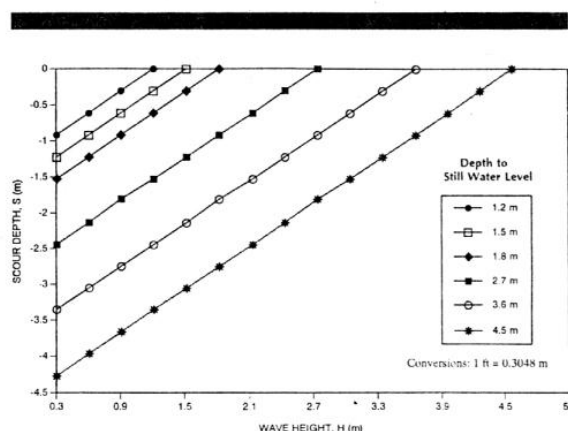
Figure 4. Scour depth vs. wave height, for reflection coefficient (C.).

Predicted scour depths from Equation 1 for a depth to SWL of 1.8 m (6 ft) and various values of the coefficient of reflection is presented in Figure 3. Because C_r is to be taken as 1.0 for design purposes, a graph of scour depth versus wave height for several values of depth to SWL is presented in Figure 4 for C_r equal to 1.0. In these figures, the negative sign represents scour, or sand being removed from the front of the wall. The general trend is the decrease in scour depth with the increase in wave height for a given depth to SWL. Also, for a given wave height, the scour depth increases, with an increase in depth to SWL. As the reflection coefficient increases, the scour depth increases until H/d (wave height/water

depth to SWL) is approximately 0.7, which is generally accepted as the initiation point for breaking waves (Figure 3). It is interesting to note that the curves for the reflection coefficient cross at the approximate value for H/d of 0.7, and the scour depth begins to decrease with an increase in reflection coefficient. It should be noted that beyond the approximate value of 0.7 for H/d , Equation 1 may no longer be valid, because it was developed for nonbreaking waves and not for breaking waves.
